DucTALES

MAY/JUNE 2005

Commercial Coil Cleaning:

A Case History

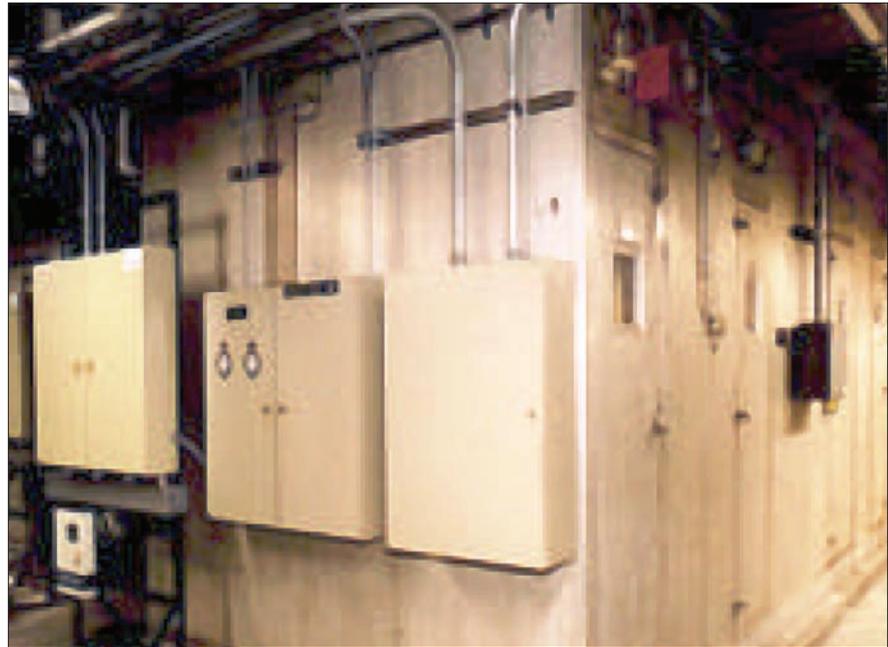
Figure 1: Air Handler Unit—Each AHU is designed to provide approximately 20,000 CFM of conditioned air to a space containing a volume of approximately 80,000 cubic feet, thus creating 15 air exchanges per hour or a fresh air turnover every four minutes.

Each AHU is designed to provide approximately 20,000 CFM of conditioned air to a space containing a volume of approximately 80,000 cubic feet, thus creating 15 air exchanges per hour or a fresh air turnover every four minutes. The dimensions of a typical CSRB AHU are 25 feet long, 10 feet wide, and 8 feet high (shown in Figure 1). Each AHU contains three distinct coils (reclaim, heat, and cooling) and is compartmentalized as designated in
