POLYMER RESURFACING AHU Drain Pan Restoration

Polymer Resurfacing - AHU Drain Pan Restoration

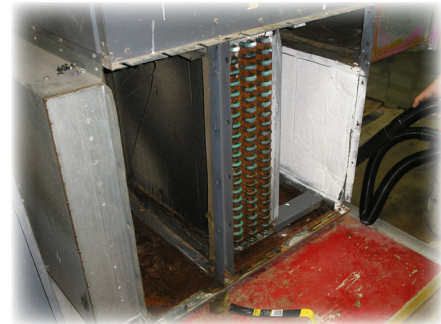
AHU unit prior to restoration

Condensate leaks in drain pans are a substantial and costly problem. The thin metal drain pans have uneven areas where water collects causing corrosion. Pinholes then develop from the corrosion and water leaks onto the subfloor and floor below. The stagnant water creates breeding areas for fungal and other microbial growth. The cost of replacing the corroded area can become quite expensive. The specific pan may no longer be available and may need to be special ordered or fabricated or the entire system may need to be replaced. Facility managers now have a viable solution to expensive replacement and equipment downtime.

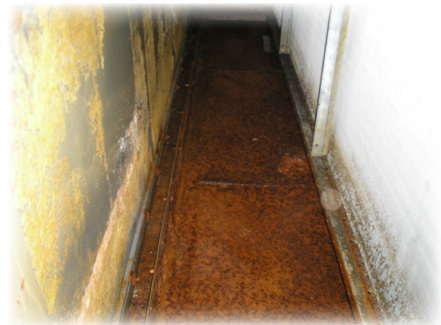
Cleaning of rust and debris

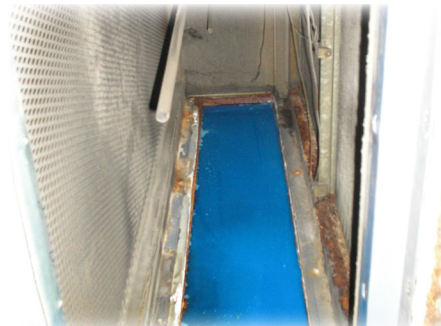
Completed polymer resurfacing
